FLIGHT MEASUREMENTS OF THE RUDDER CONTROL AND SIDESLIP

CHARACTERISTICS OF FOUR VERTICAL TAIL ARRANGEMENTS

ON THE P-40 SERIES AIRPLANES -

MEMORANDUM REPORT

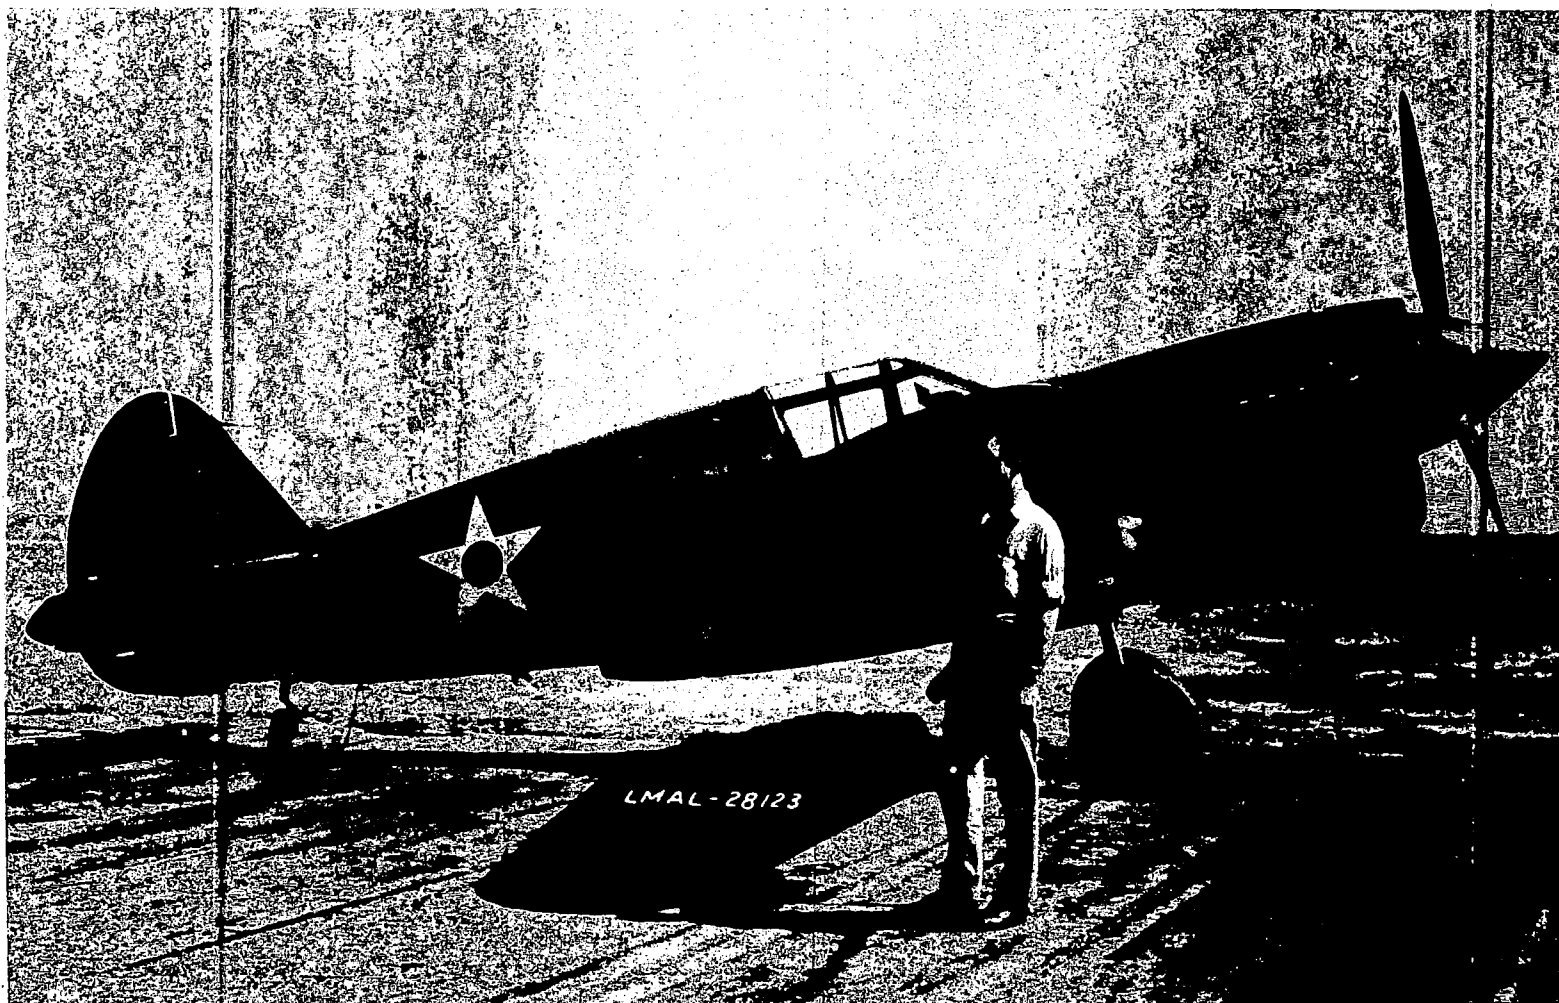
Figure 1.- Side view of Curtiss P-40E airplane with original vertical tail surfaces.

Photographs of the four tail arrangements tested are shown in figures 1 through 6. Tests of the original vertical tail, Curtiss fin extension no. 1, and Curtiss fin extension no. 6 on a tall fin (Curtiss dwg. SK-5524) and rudder (Curtiss dwg. SK-5676) were made on a P-40E airplane. Flight measurements with the original vertical tail moved aft 20 inches were conducted on a modified P-40F airplane.

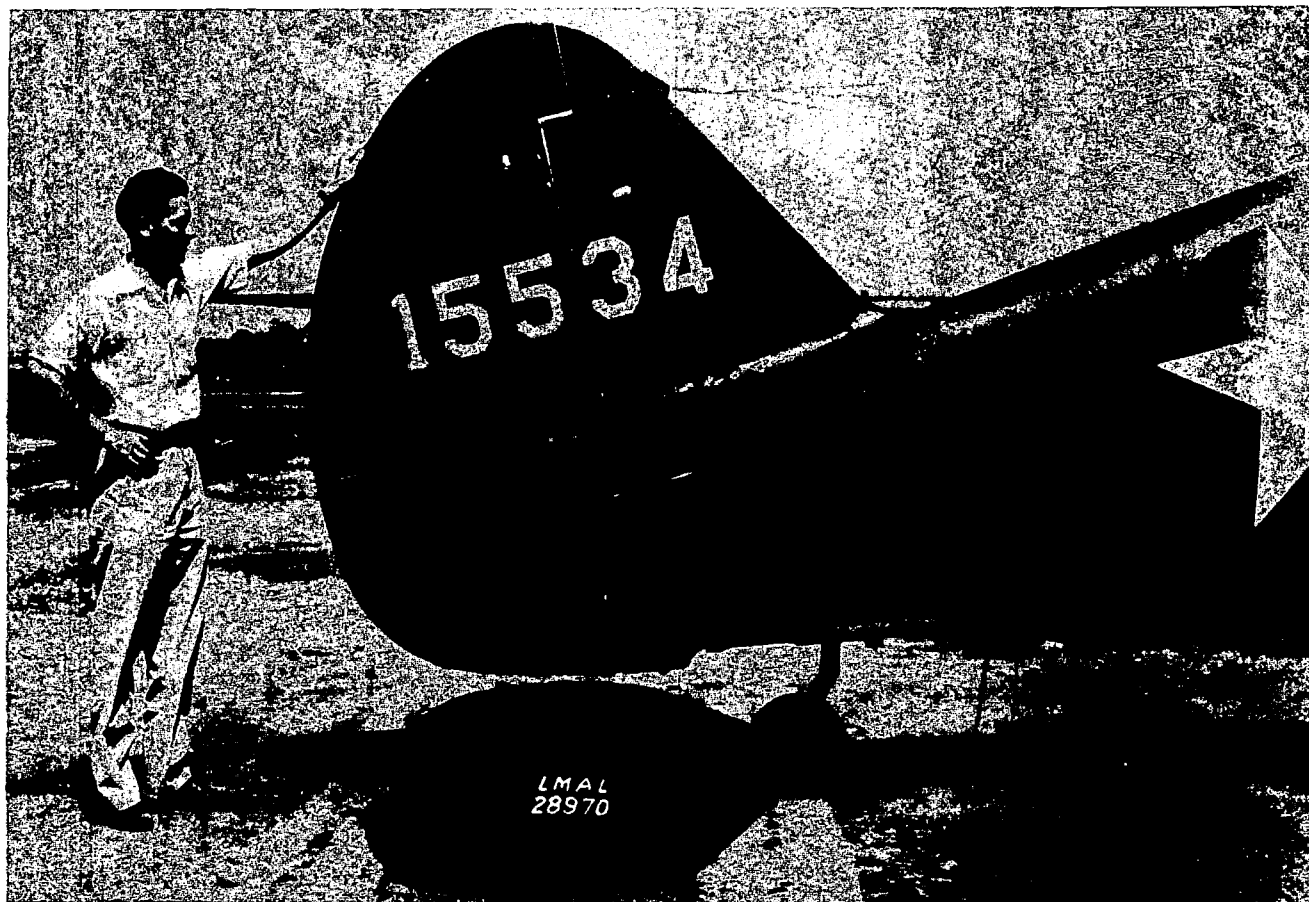
Figure 2.- Side view of original P-40E vertical tail.

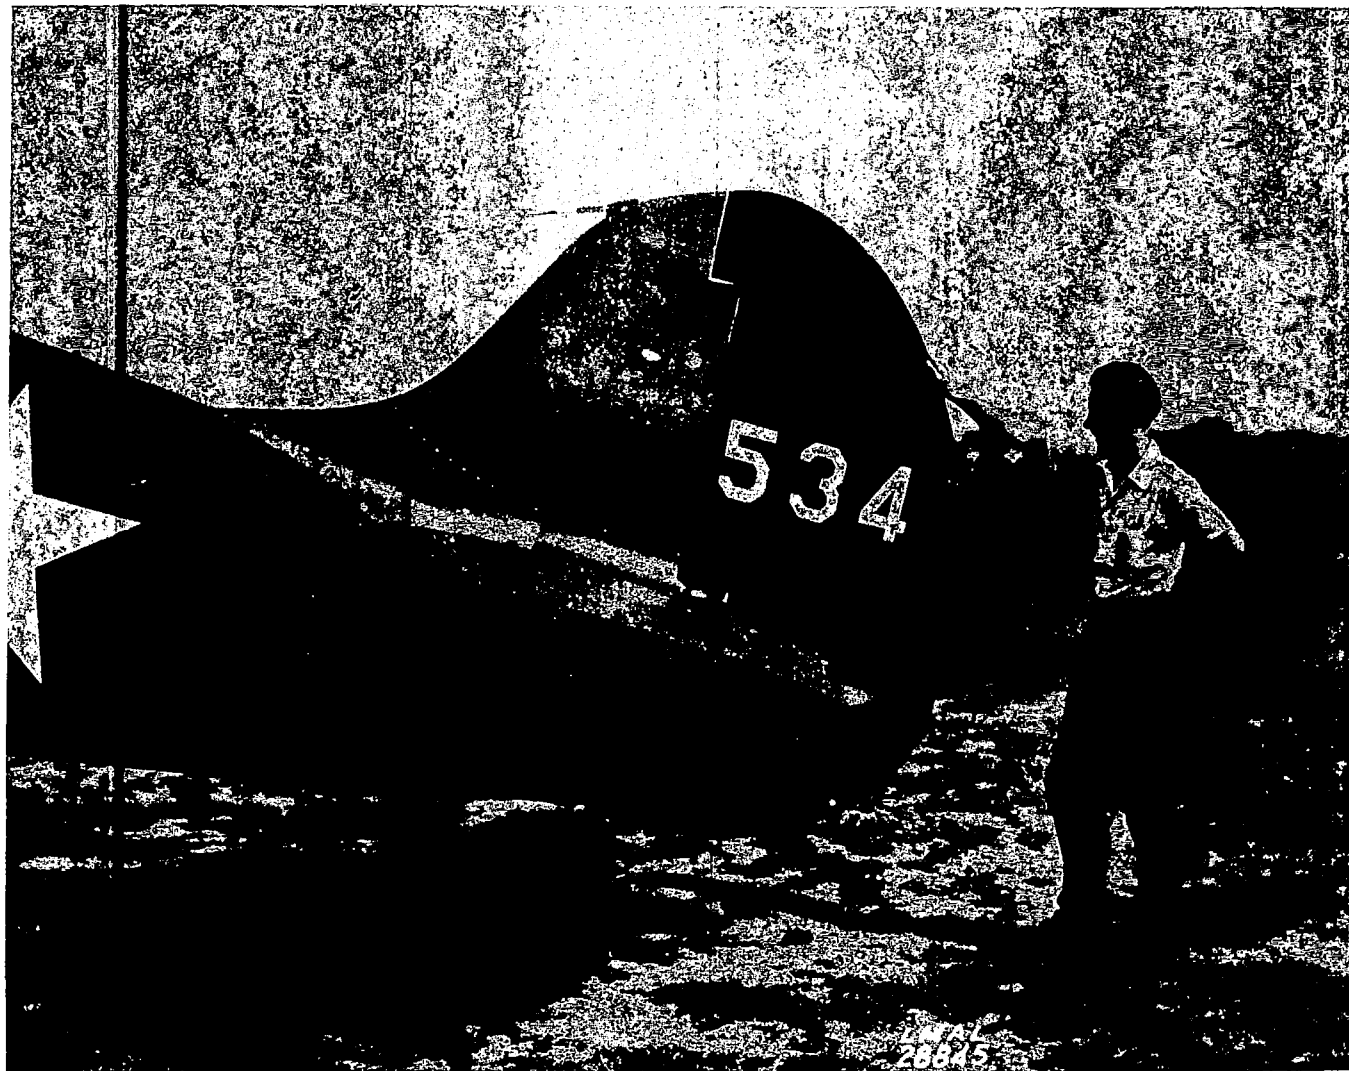
Figure 3.- Side view of Curtiss fin extension No. 1 on original P-40 vertical tail.

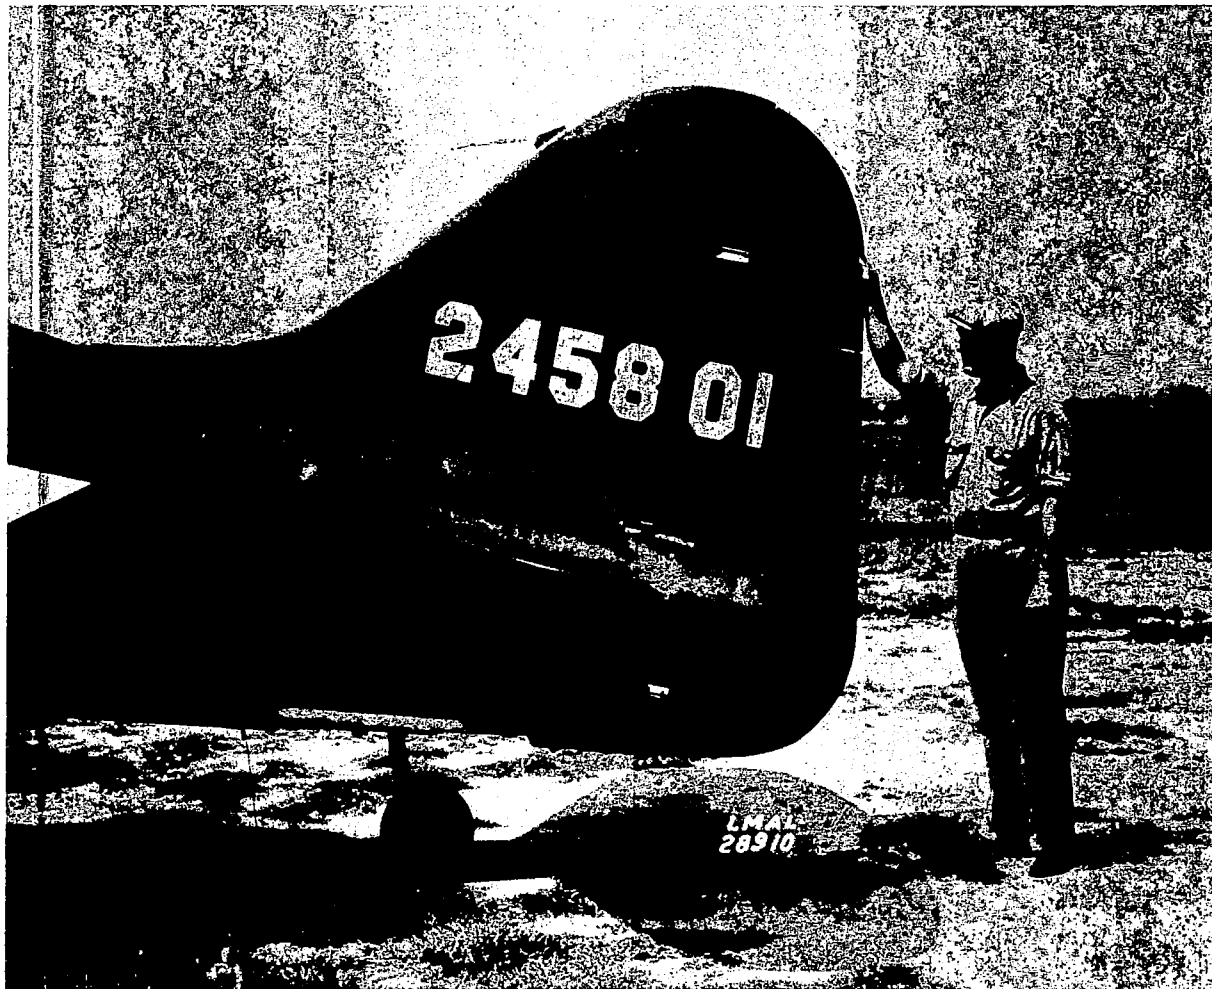
Figure 4.- Side view of Curtiss fin extension No. 6 on a tall fin
(Curtiss DWG. Sk-5524) and rudder (Curtiss DWG. Sk-5676).

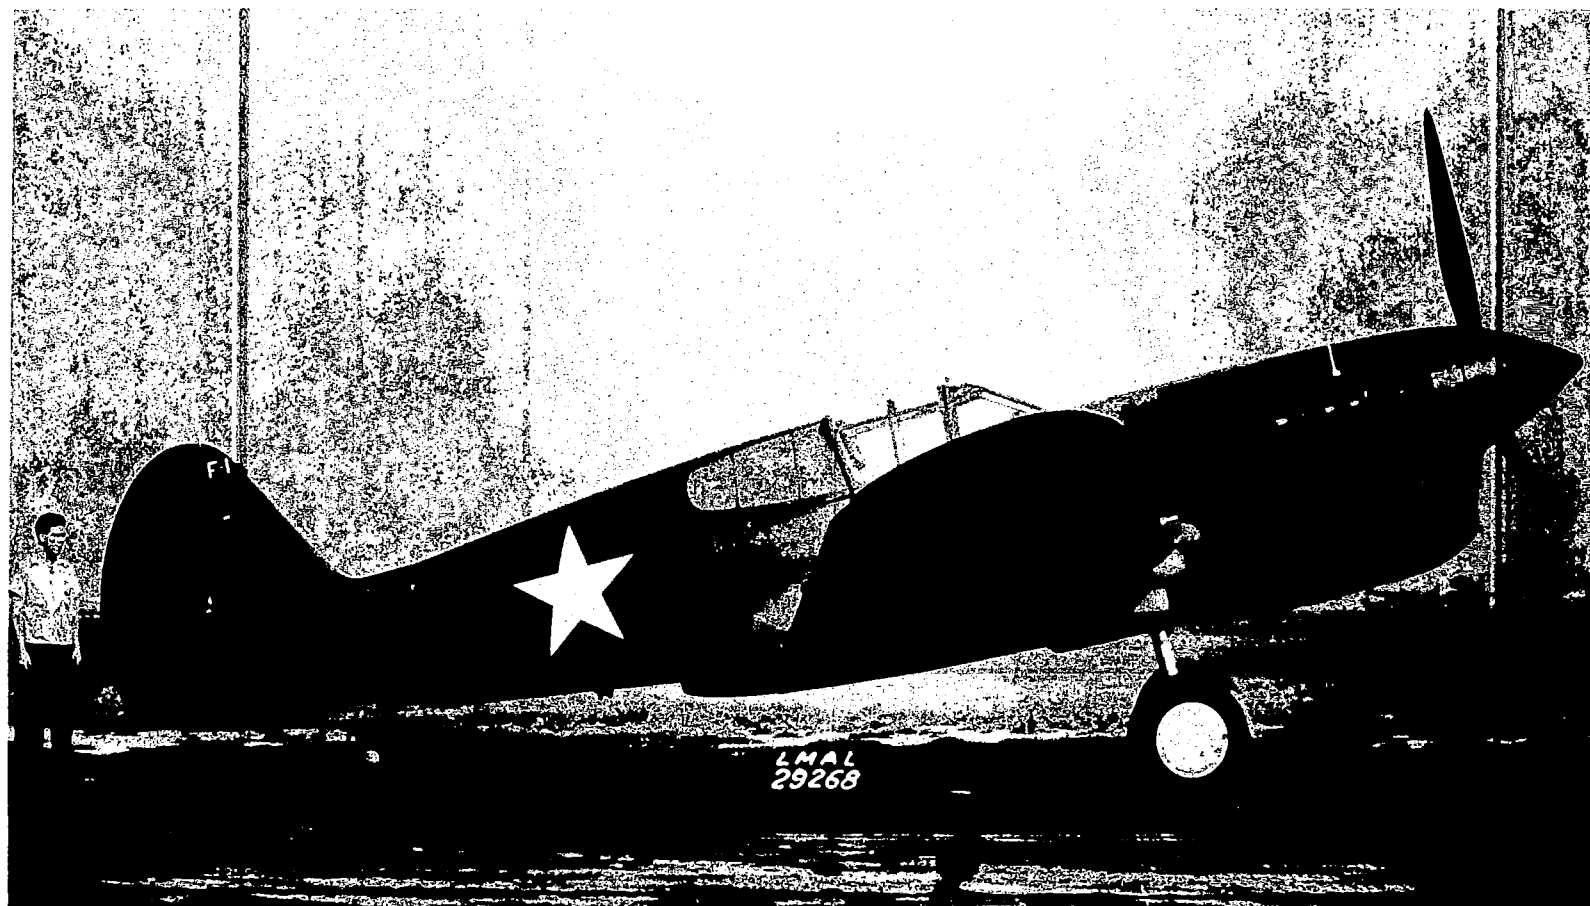
Figure 5.- Side view of Curtiss P-40F airplane with an original vertical tail on a 20-inch fuselage extension.

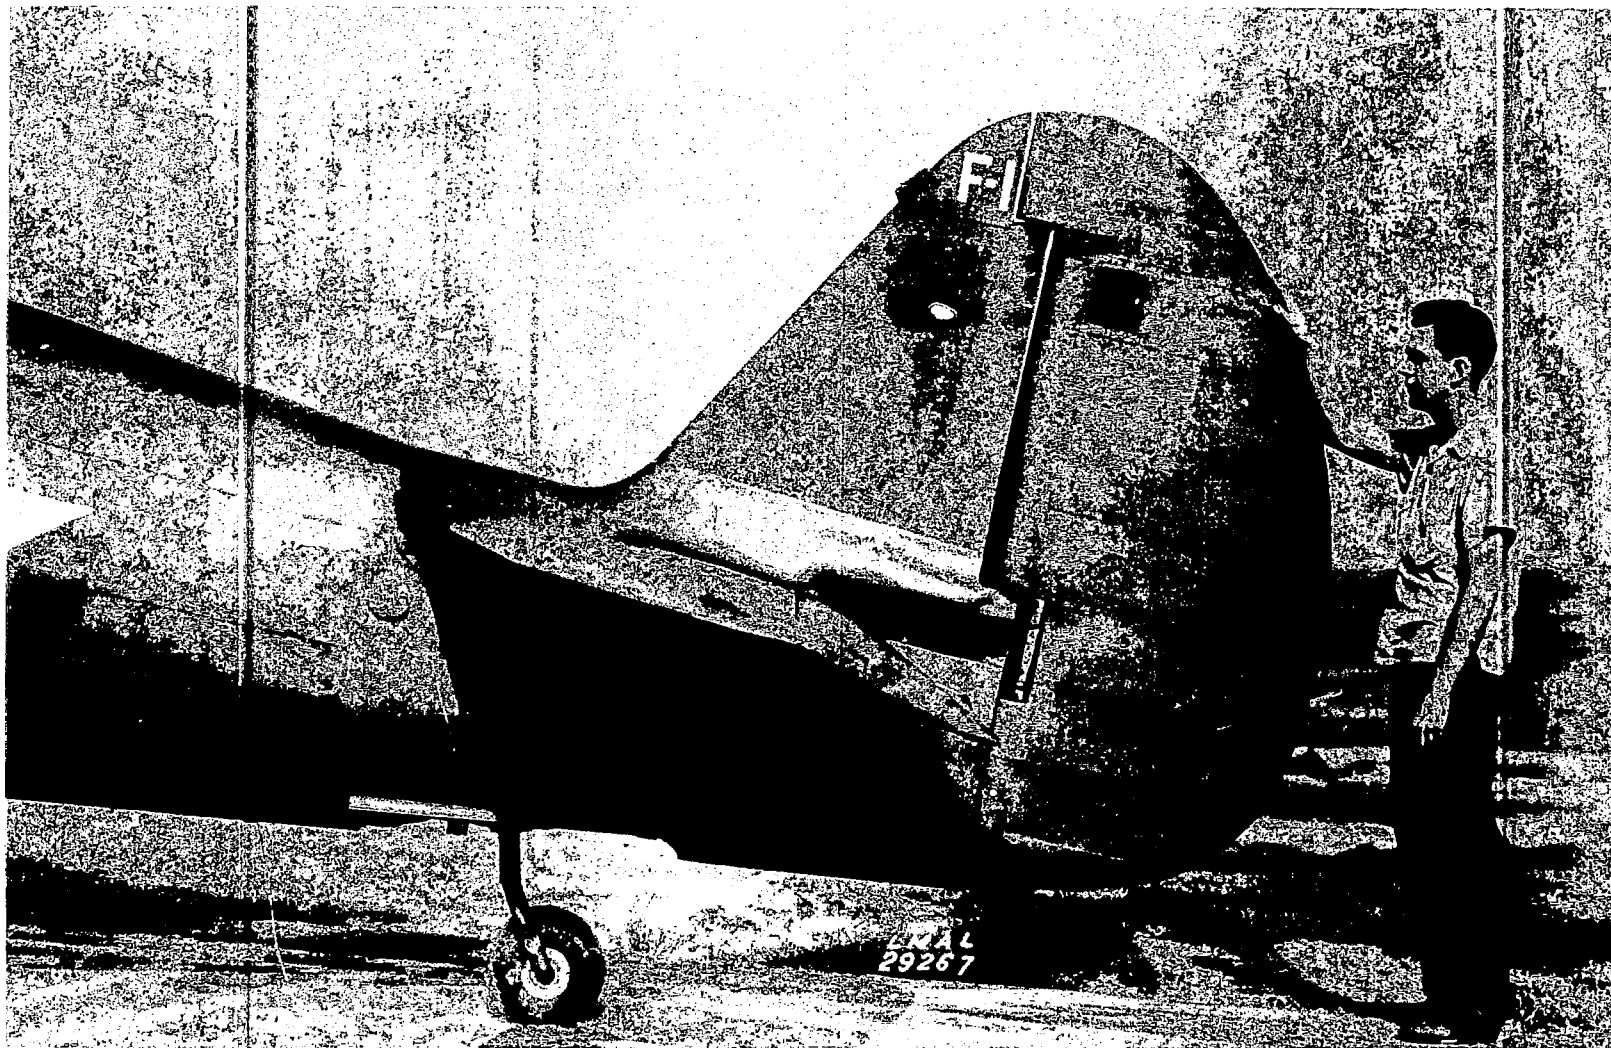
Figure 6.- Side view of original vertical tail on the P-40F airplane with a 20-inch fuselage extension.

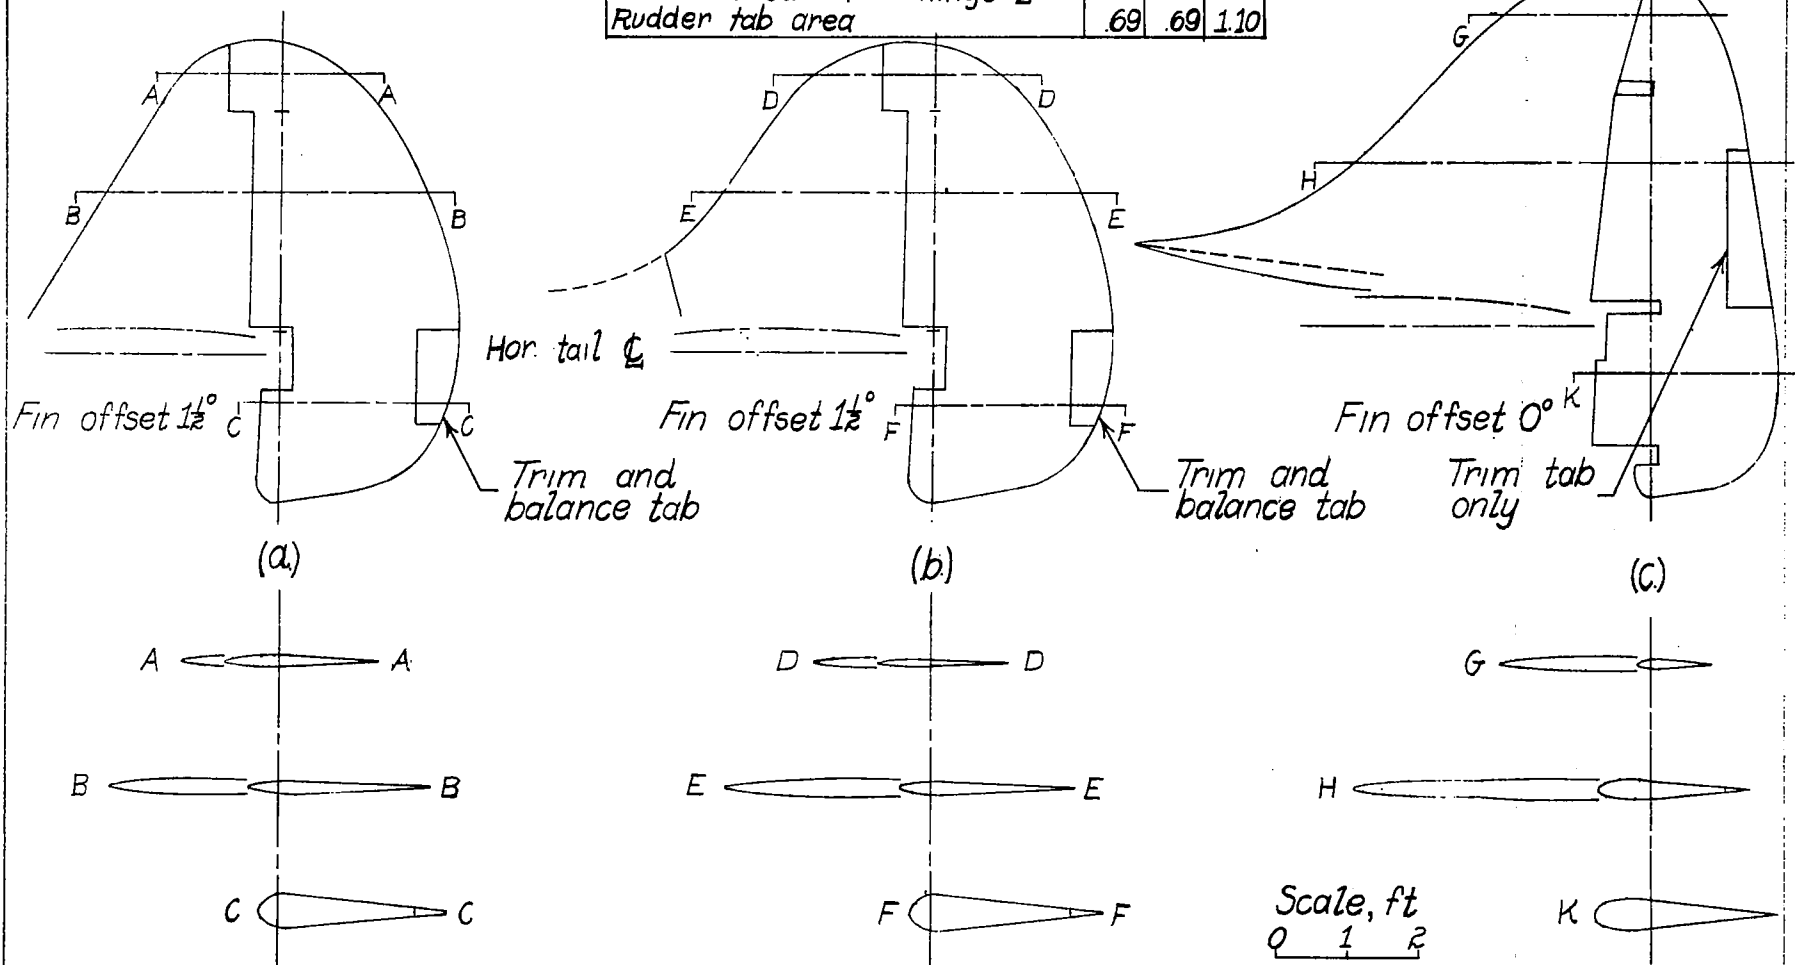
Approximate areas, sq. ft.	(a)	(b)	(c)
Total vertical tail area	22.0	23.4	28.7
Fixed fin area	7.5	8.9	15.2
Total rudder area	14.5	14.5	13.5
Rudder area forward of hinge ϵ	2.5	2.5	3.8
Rudder area aft of hinge ϵ	12.0	12.0	9.7
Rudder tab area	.69	.69	1.10

Figure 7a. - Vertical tails tested on P-40E airplane: (a) original P-40E vertical tail; (b) fin extension no. 1 on original vertical tail; (c) fin extension no. 6 on tall fin (Curtiss dwg. SK-5524) and rudder (Curtiss dwg. SK-5676).

Line drawings of the vertical tail surfaces, that is, the original vertical tail, Curtiss fin extension no. 1, and Curtiss fin extension no. 6, along with their respective areas, are shown on figure 7. The rudder of the original vertical tail surfaces and of that used with fin extension no. 1 were equipped with balancing trim tabs, while the rudders used with Curtiss fin extension no. 6 and the 20-inch fuselage extension on the P-40F airplane were equipped with trim tabs only. The relations between rudder trim tab position, rudder position, and cockpit tab setting are shown on figures 8 through 11. The fin offset on the original vertical tail and on the tail with fin extension no. 1 was $1-1/2^{\circ}$, while the fin offset for fin extension no. 6 and the 20-inch fuselage extension was 0° .

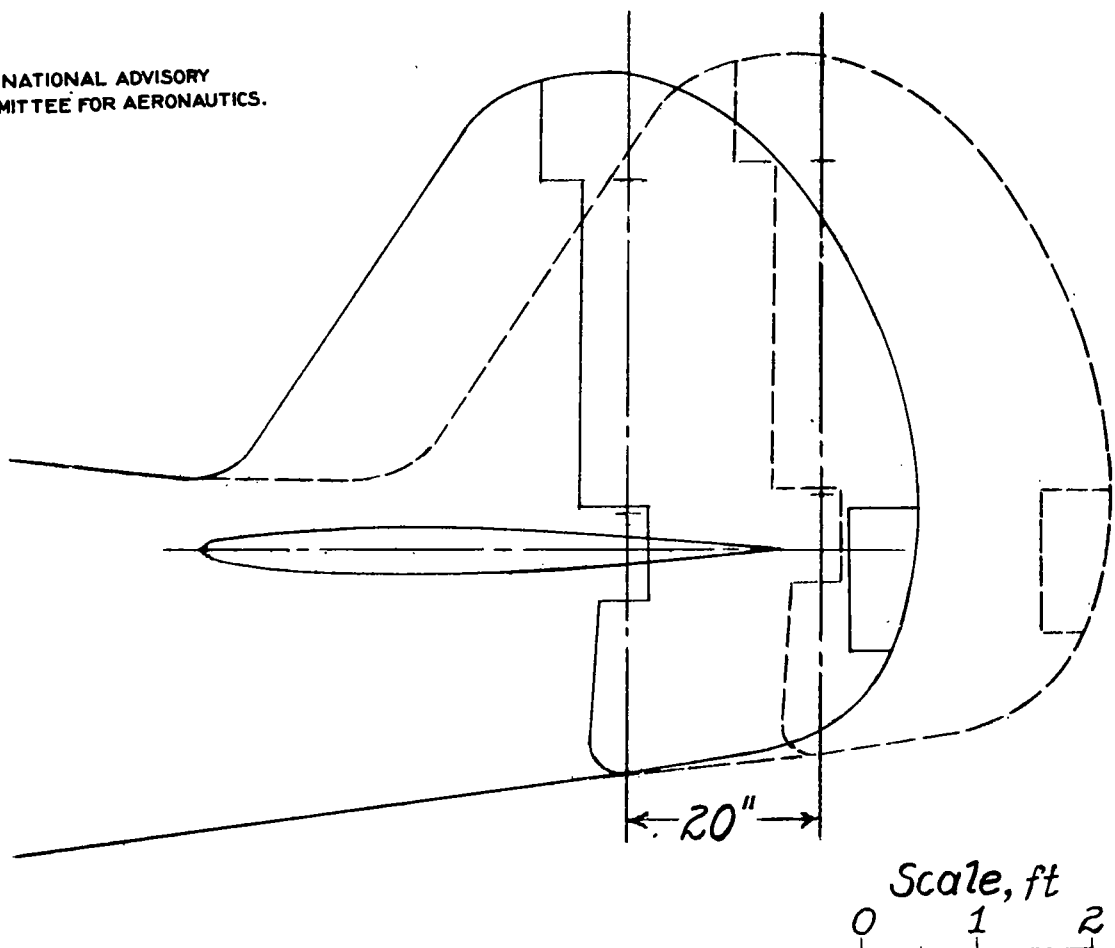
- P-40E Airplane
Fin offset $1\frac{1}{2}^\circ$
Trim and balance tab
- P-40F Airplane
Fin offset 0°
Trim tab only
20" fuselage extension

Figure 7b. - Comparison of original vertical tail arrangements tested on the P-40E airplane and on the P-40F airplane with the extended fuselage.

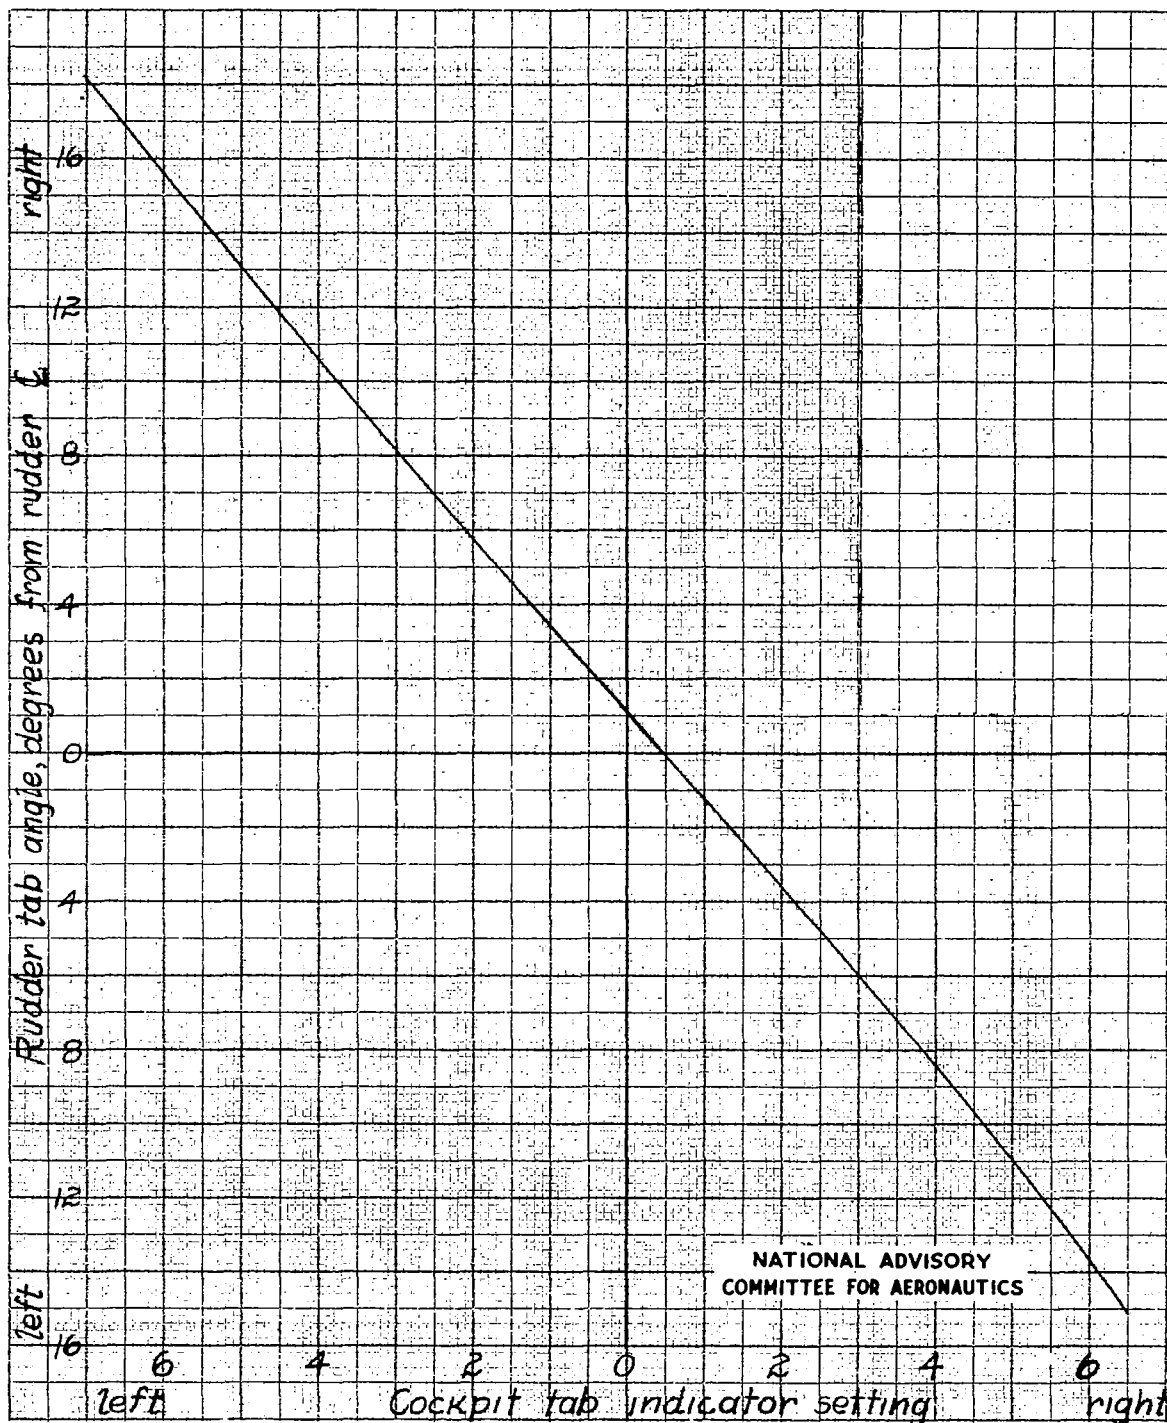
Figure 8.- Relation between rudder tab position and cockpit indicator setting with rudder parallel to thrust axis, P-40E airplane, original vertical tail with and without fin extension no. 1, fin offset 1-1/2°.

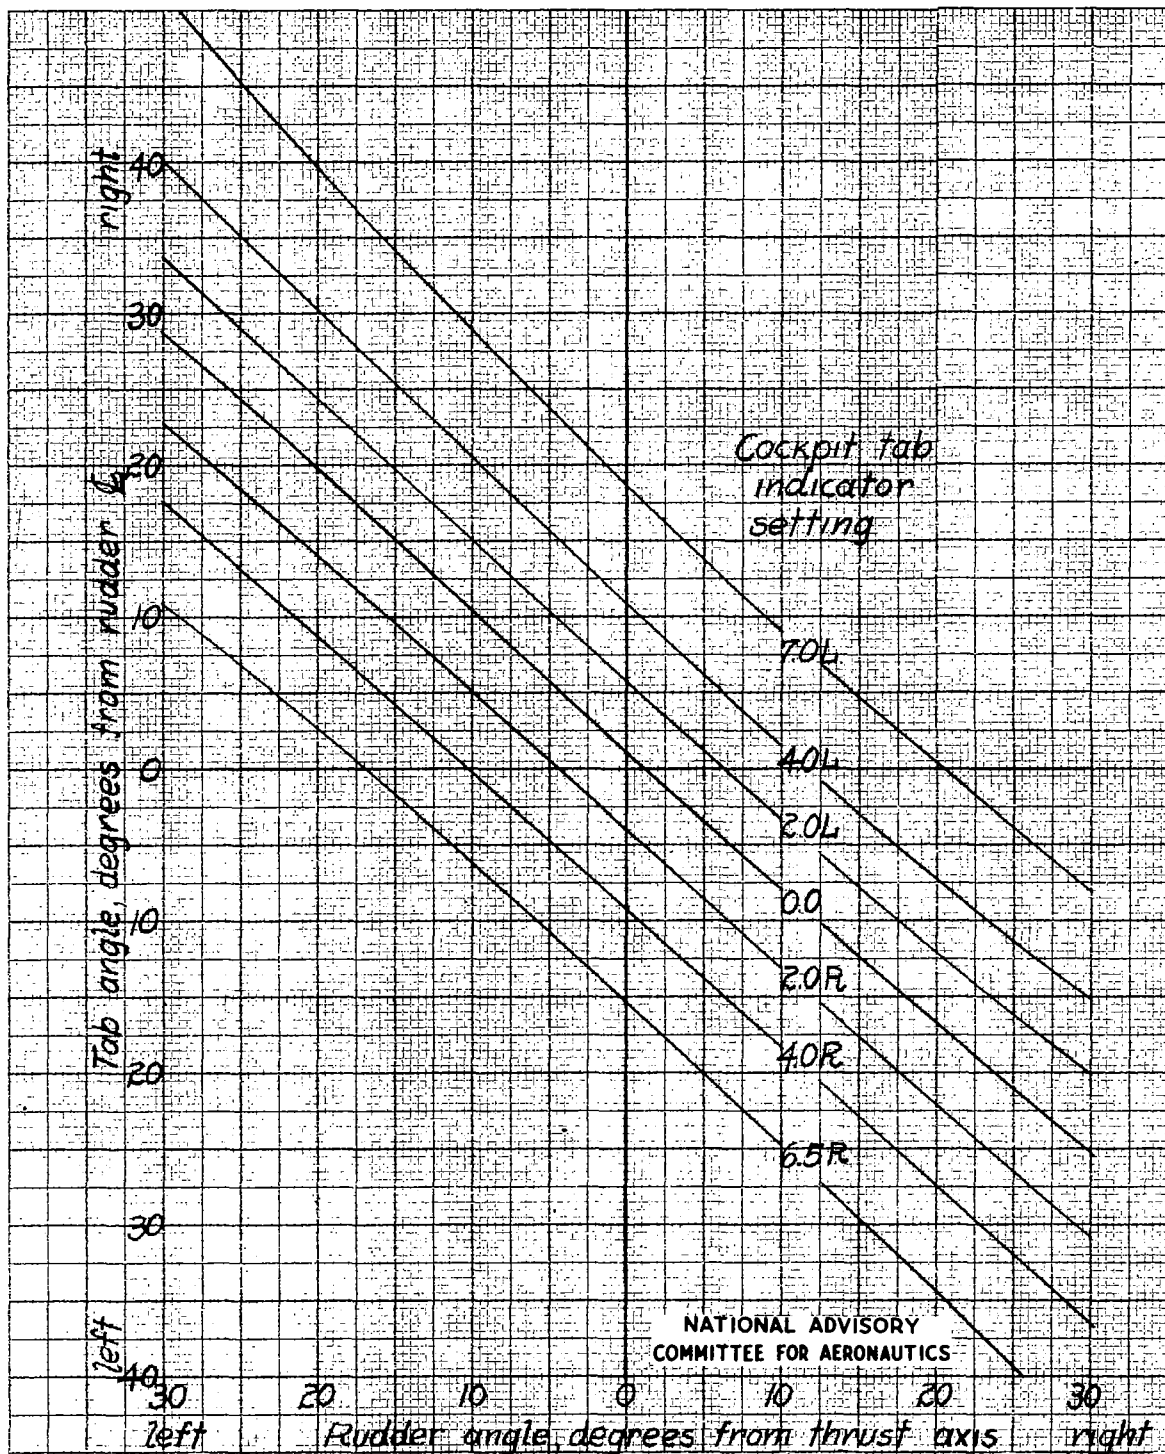
Figure 5.- Relation between rudder tab position and rudder position at various cockpit tab indicator settings, P-40E airplane, original vertical tail with and without fin extension no. 1, fin offset 1-1/2°.

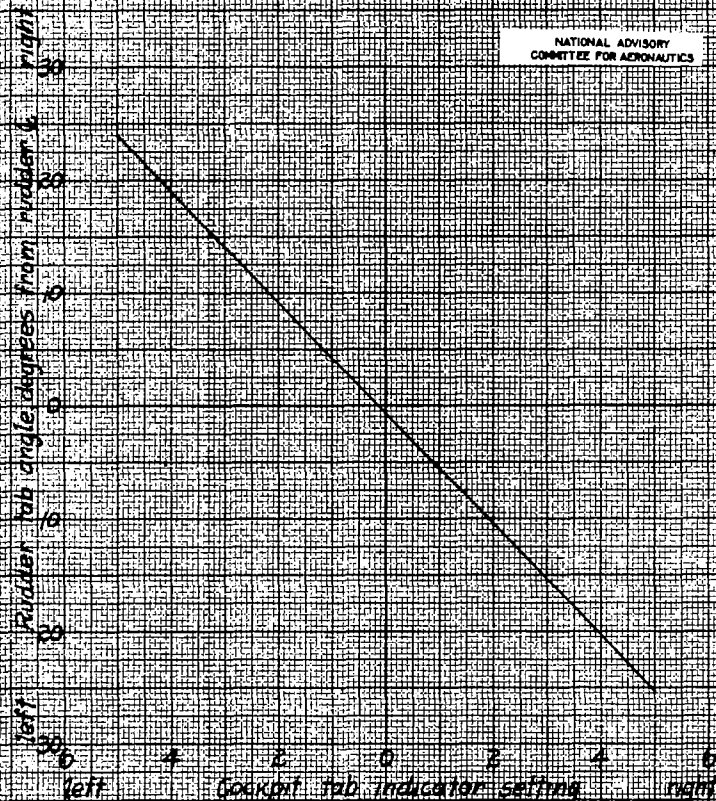
Figure 10. - Relation between rudder trim tab position and cockpit indicator setting, P-40C airplane, fin extension No. 5 on tail fin and rudder, fin offset 0°.

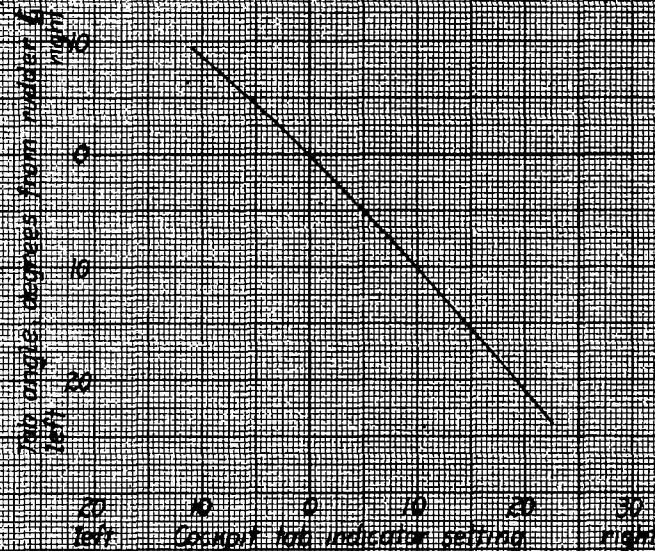
Figure 11. - Relation between rudder trim tab position and cockpit indicator setting, P-40 airplane, revised revised tail on 20-inch fuselage extension, fin offset 0°.

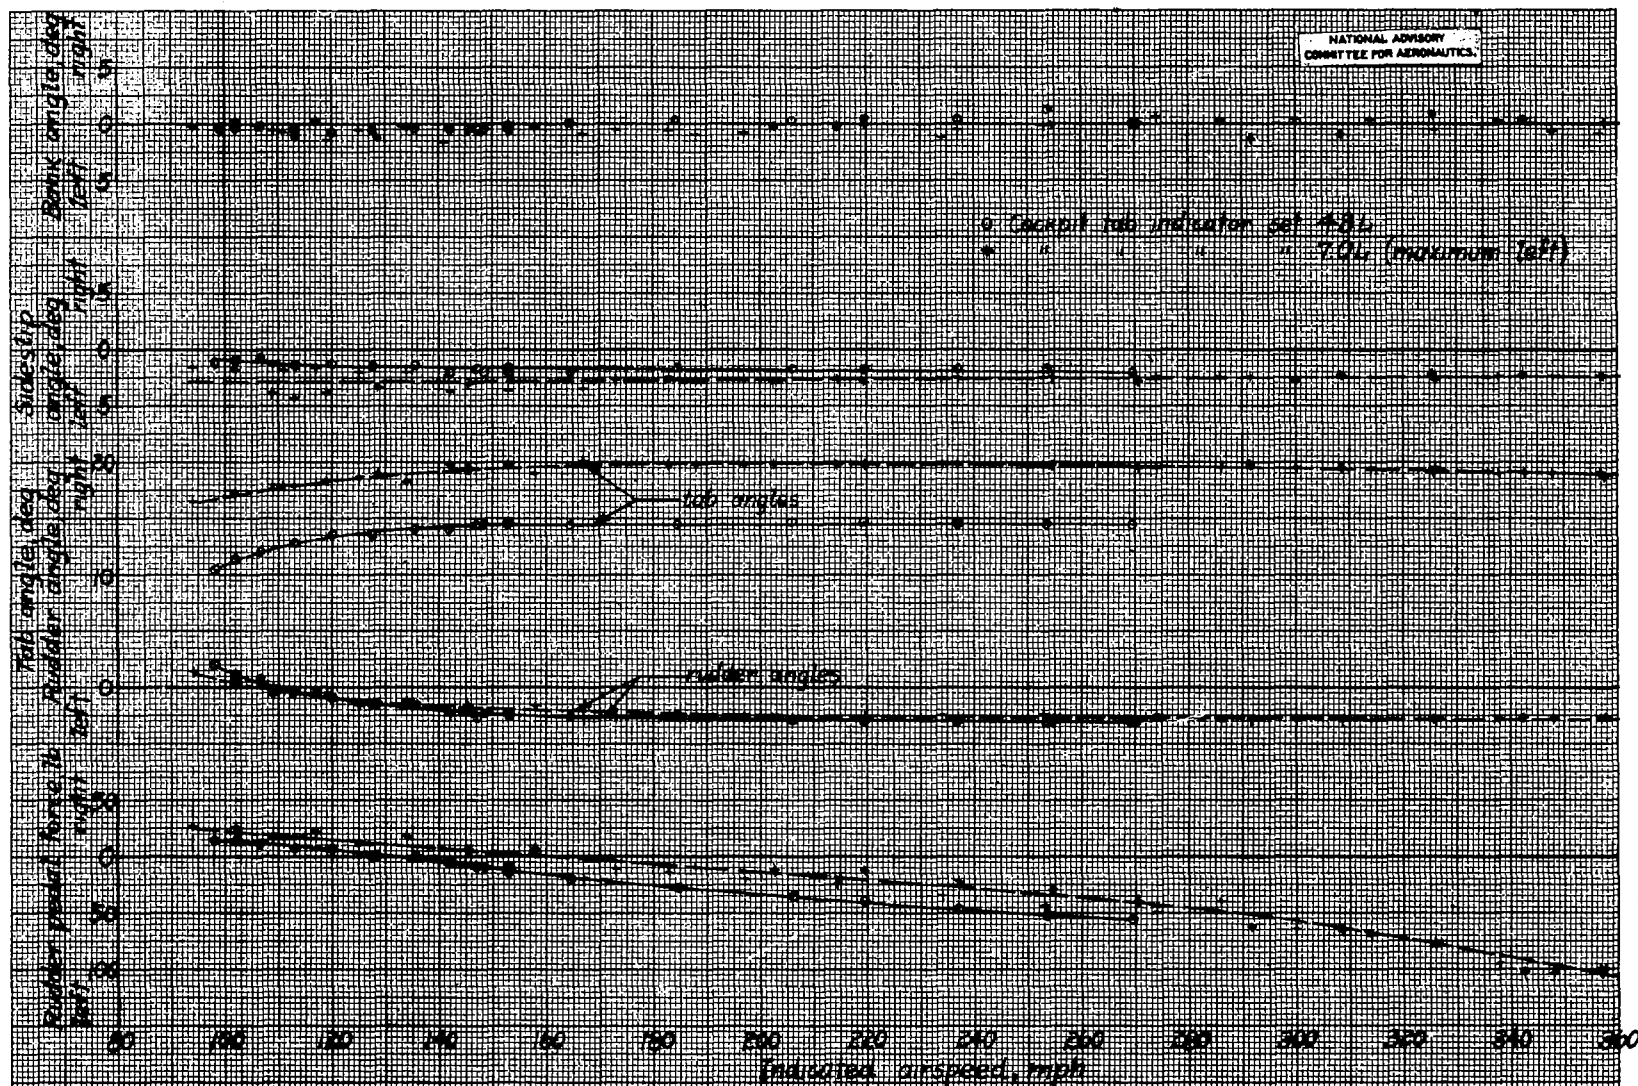
FIGURE 15. - STABILITY AND CONTROL CHARACTERISTICS, V-40 AIRPLANE, FIN EXTENSION NO. 1 ON ORIGINAL VERTICAL TAIL, FIN AREA 1.1/2', POWER OFF, CLEAN CONDITION.

The rudder-control characteristics in straight flight are presented for the four vertical tail arrangements tested in figures 12 through 23. The effectiveness of the rudder trim tabs as a function of indicated airspeed is shown on figure 24.

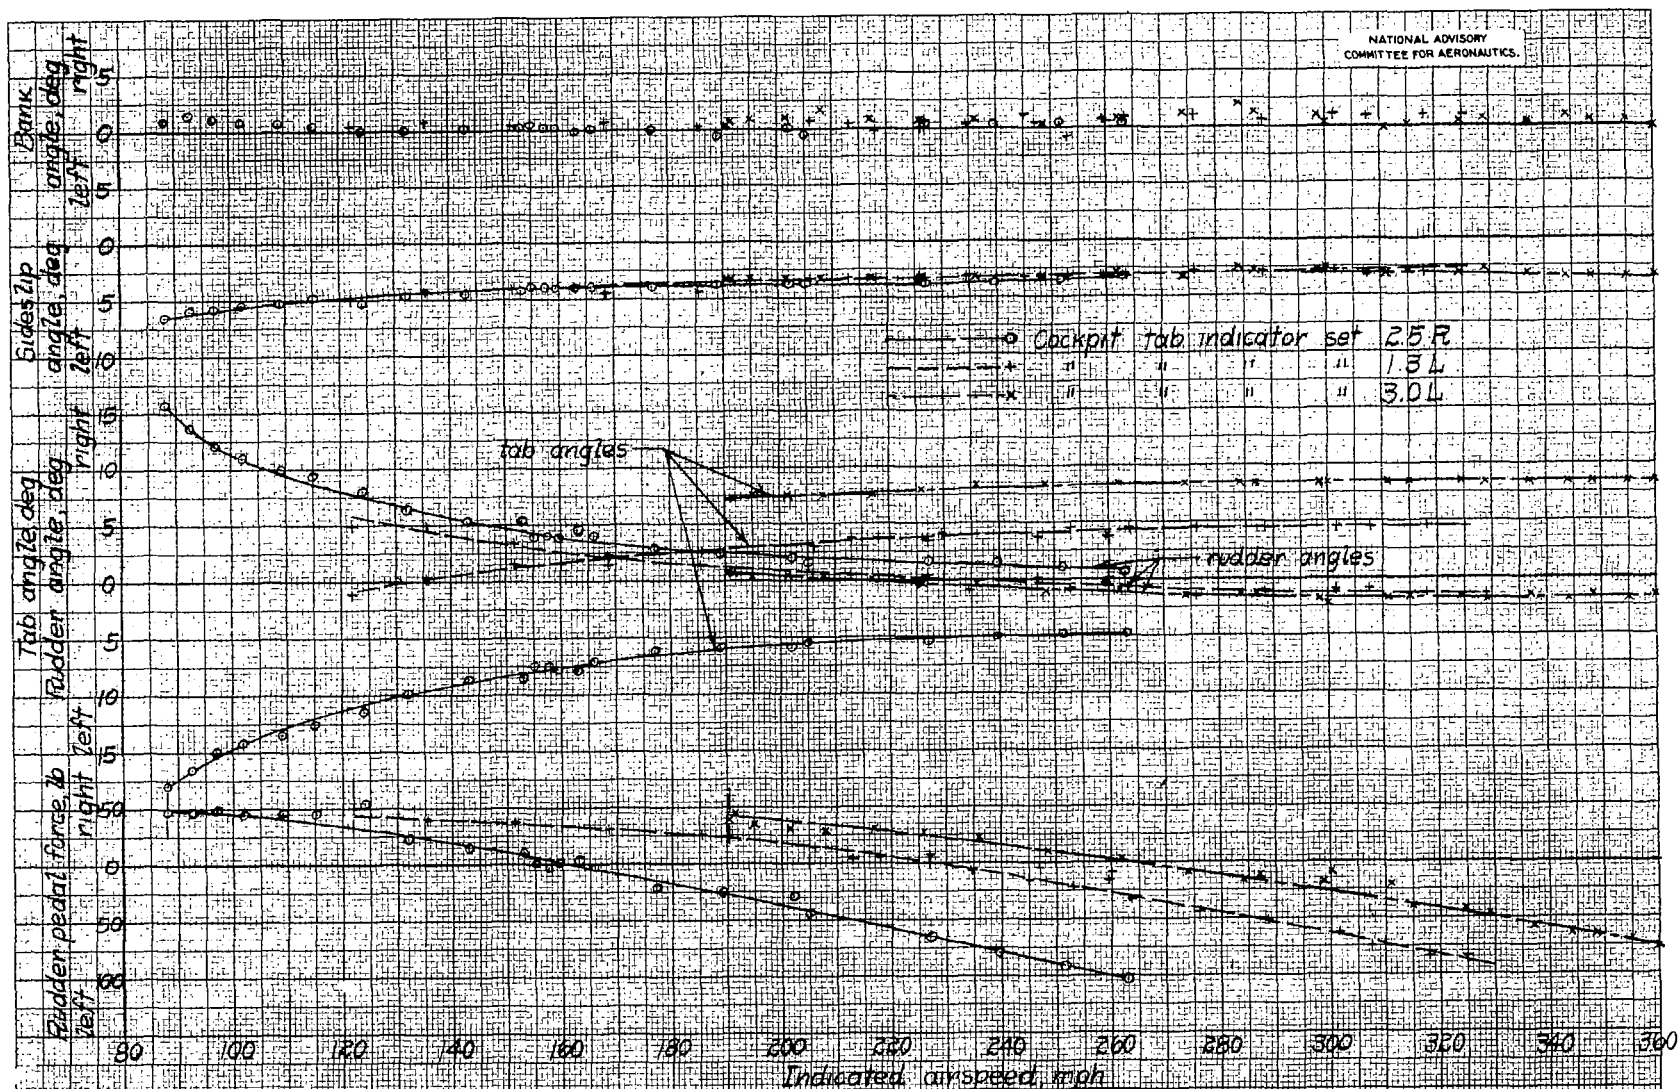
FIGURE 16. - DIRECTIONAL TRIM CHARACTERISTICS, P-40B AIRPLANE, FIN EXTENSION NO. 1 ON ORIGINAL VERTICAL TAIL, FIN OFFSET 1-1/2", RATED POWER, CLEAN CONDITION.

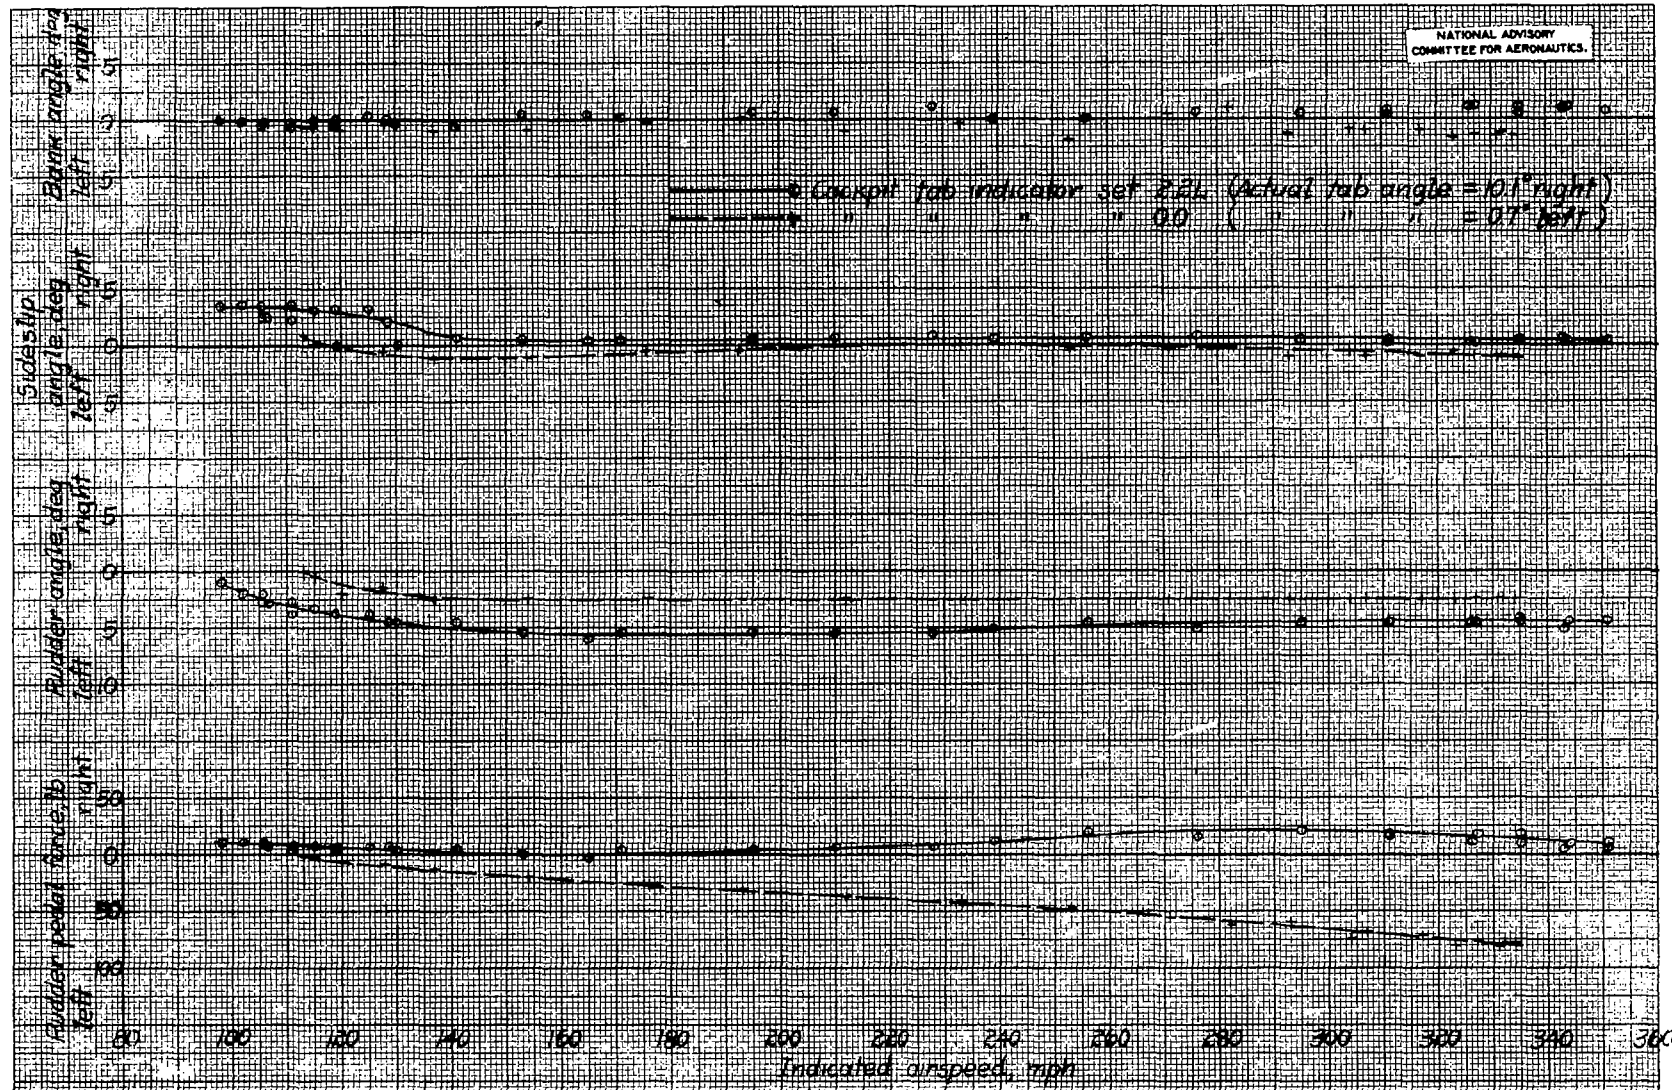
FIGURE 18. - DIRECTIONAL TRIM CHARACTERISTICS, P-40C AIRPLANE, FAN EXTENSION NO. 6 ON TAIL VERTICAL TAIL.
FAN EFFECT 0°, POWER OFF, CLEAN CONDITION.
